A SITE BACKGROUD DATA

APPENDIX A -SUMMARY OF SITE BACKGROUND INFORMATION

DUNTROON QUARRY - AMP SUMMARY REPORT (2016)

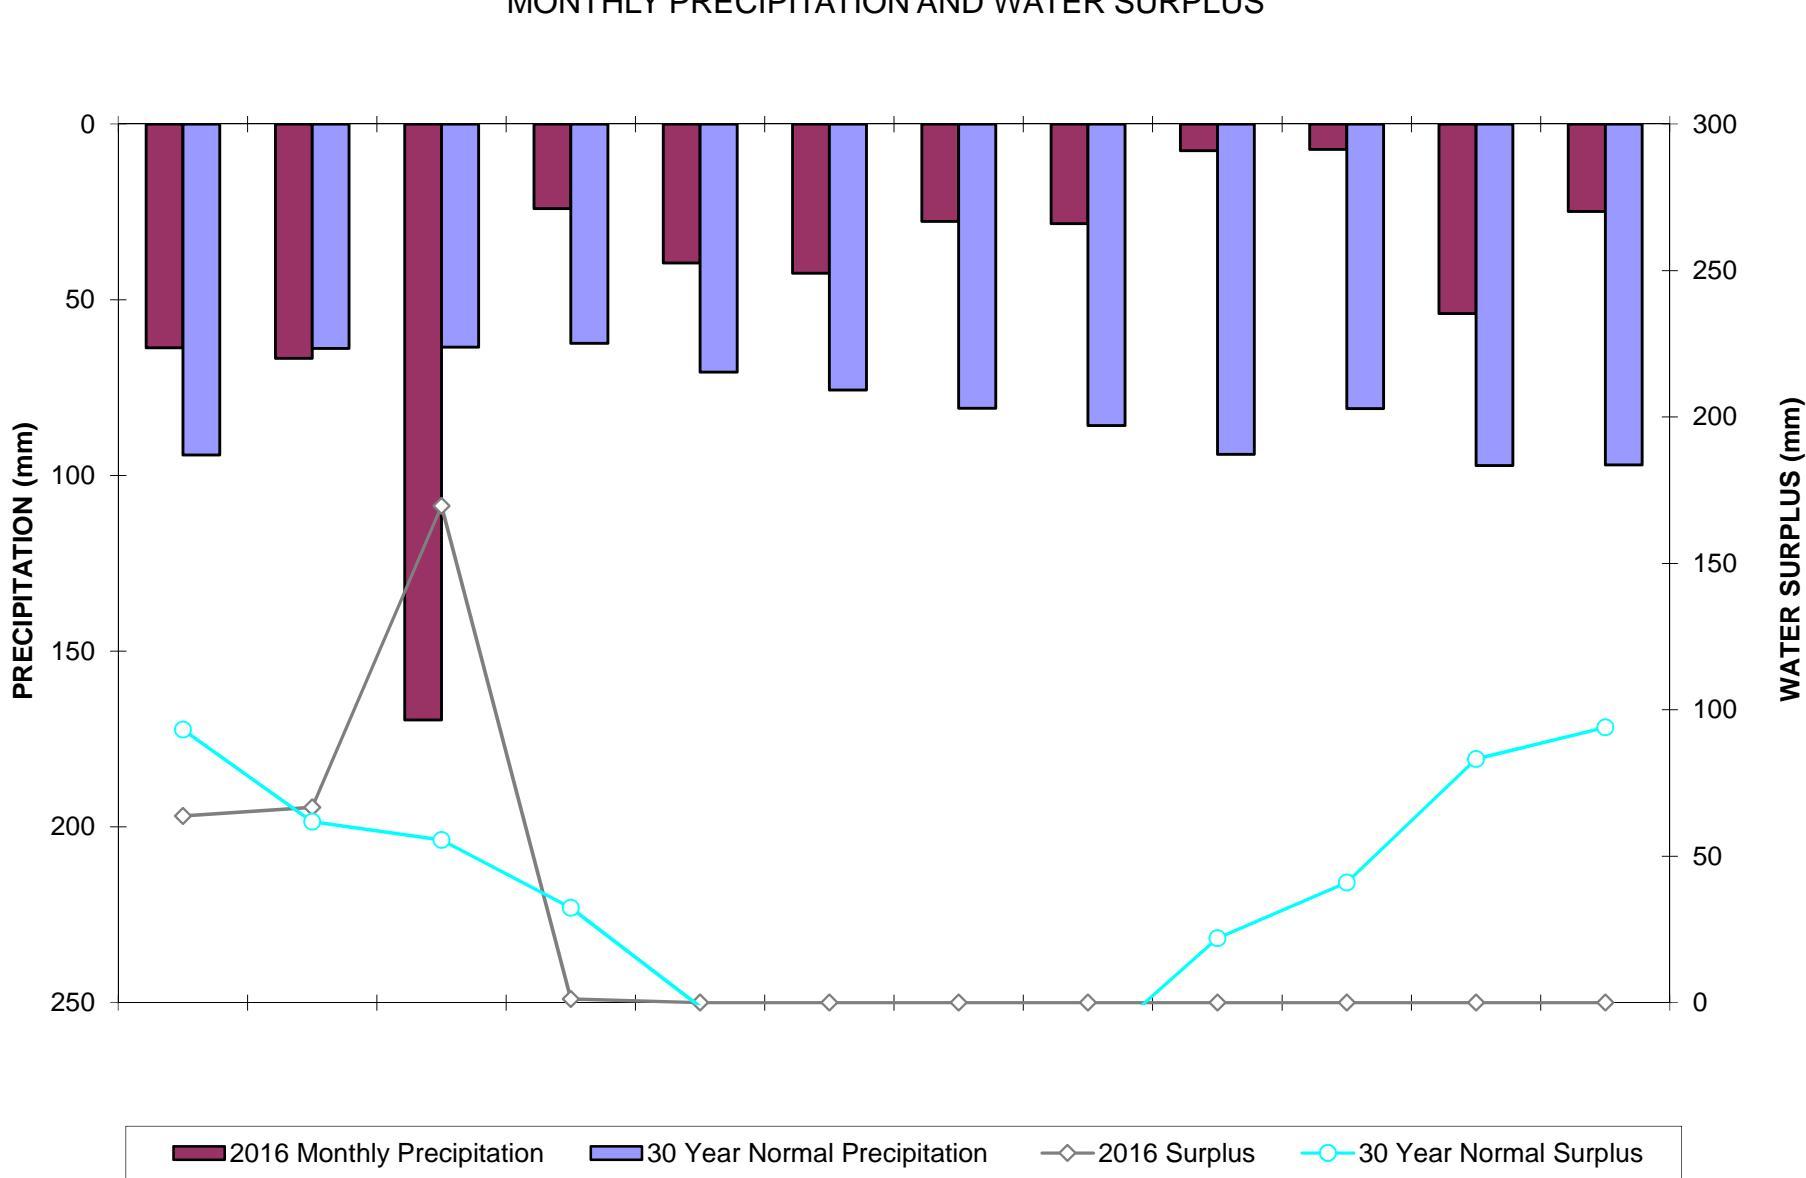
FIGURE A-3: WAI CLIMATOLOGICAL STATION

2016 AND 30 YEAR NORMAL 1971-2000 (THORNBURY SLAMA) MONTHLY PRECIPITATION AND WATER SURPLUS

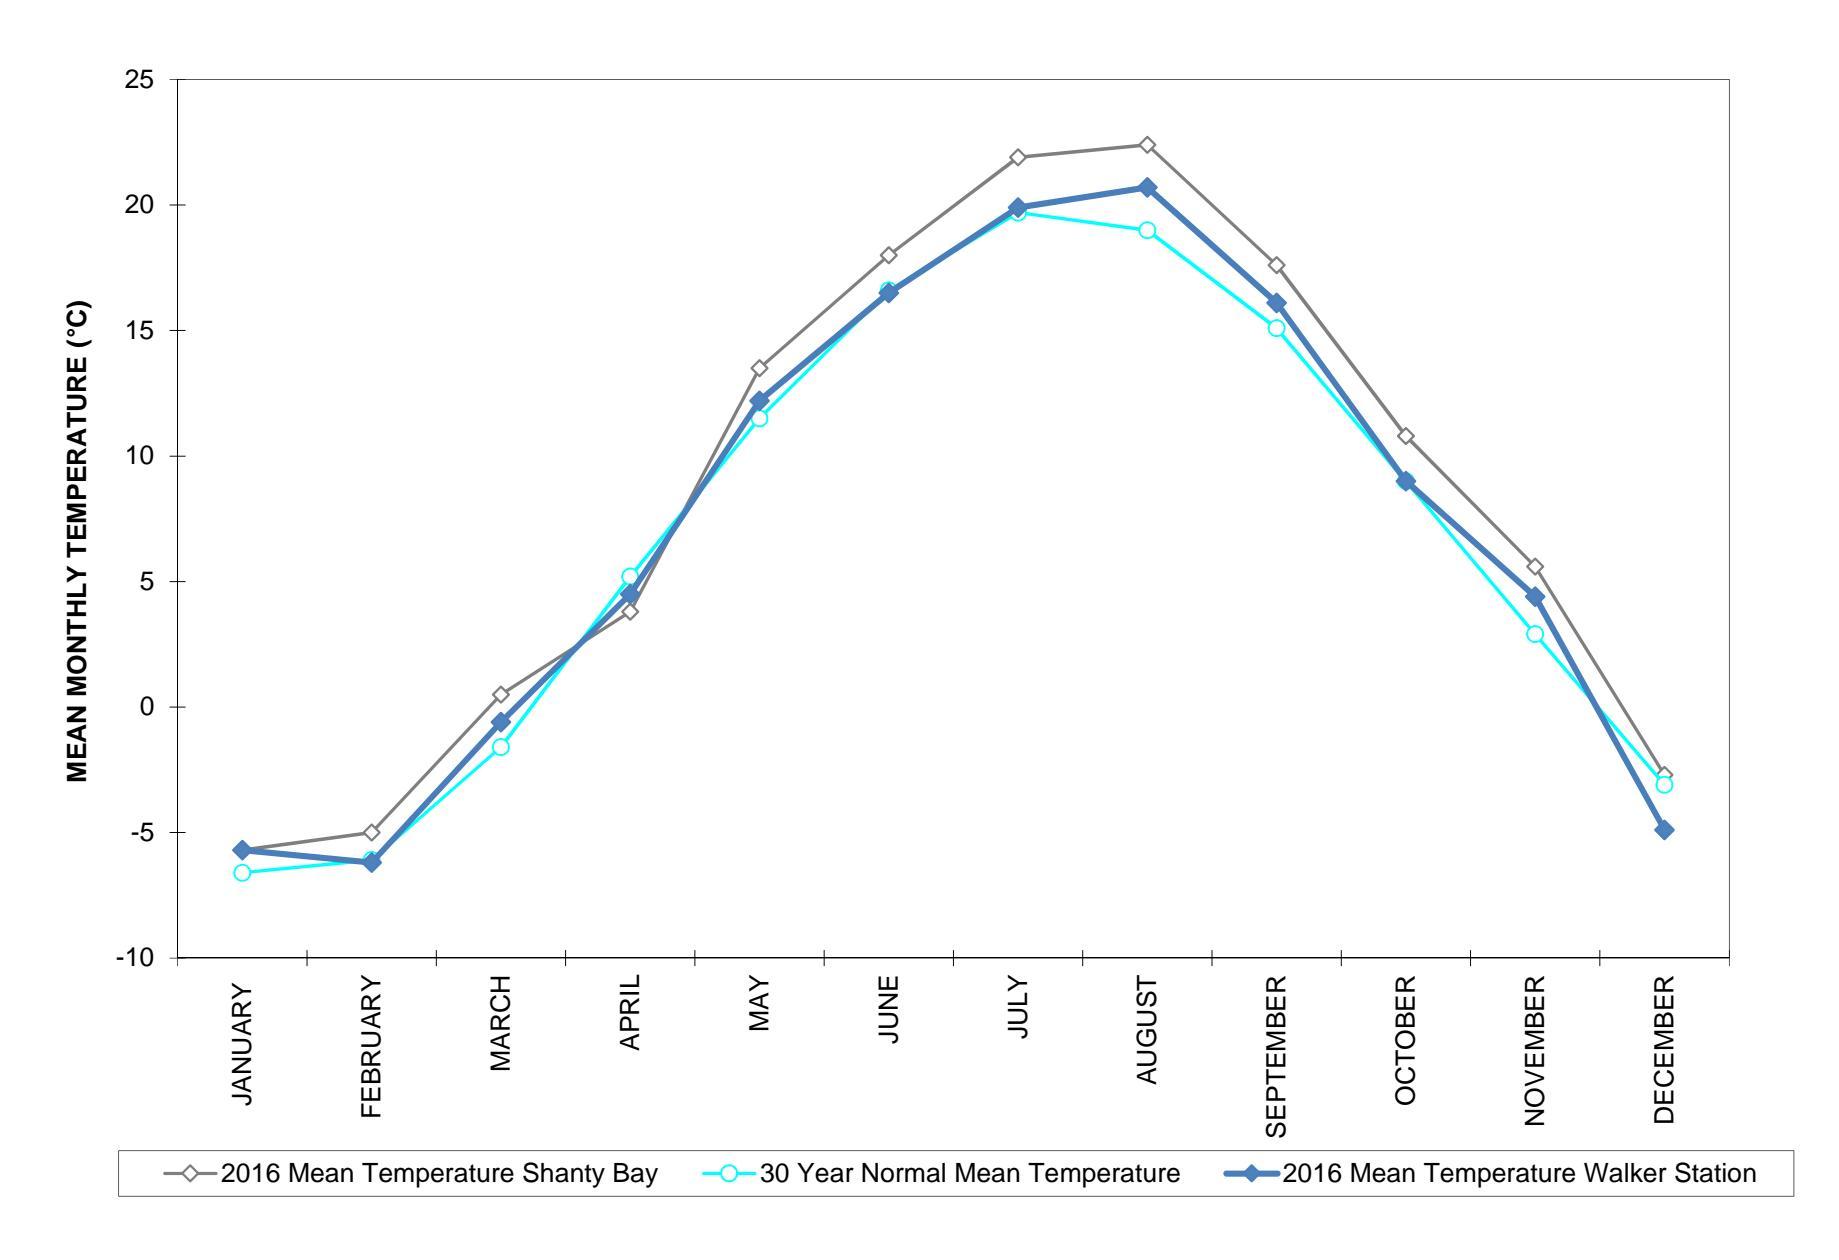
FIGURE A-4: MEAN MONTHLY TEMPERATURE

2016 (SHANTY BAY & WAI STATIONS) vs. 30 YEAR NORMAL 1971-2000 (THORNBURY SLAMA)

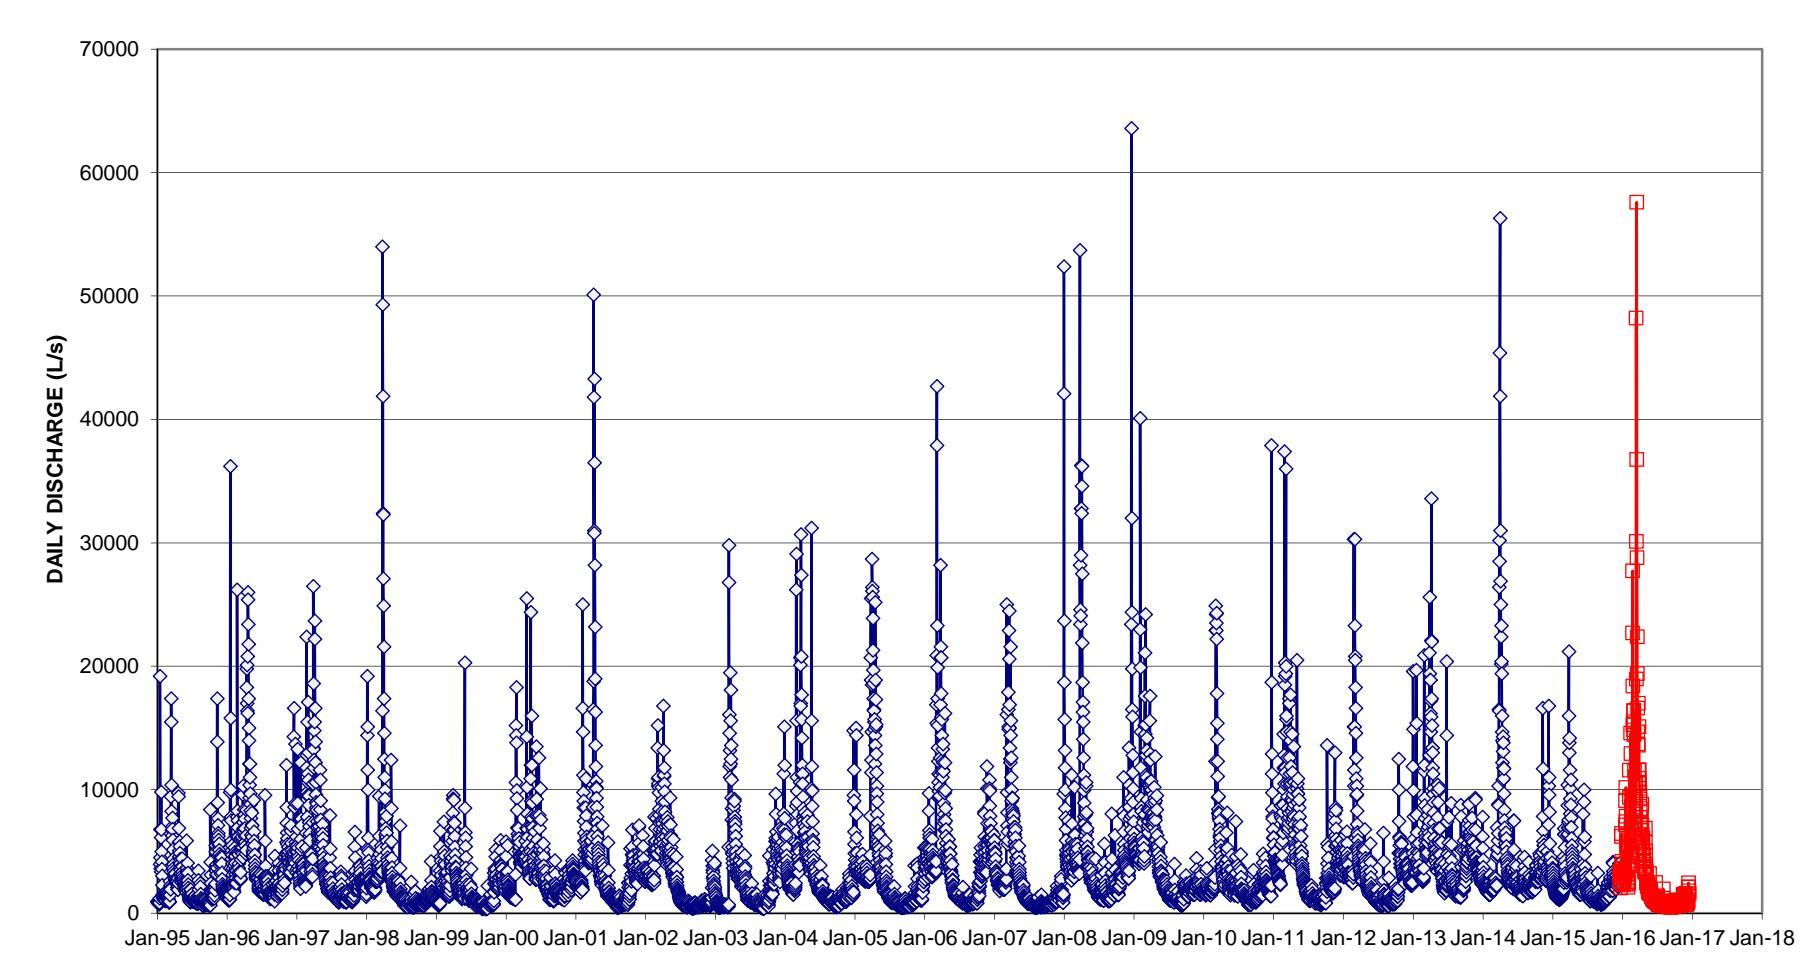
FIGURE A-6

SURFACE WATER HYDROGRAPH Mad River at Avening Environment Canada Station 02ED015

DATE NOTE: Data for this graph obtained from Government of Canada Hydrometric Data Station 02ED015. (https://wateroffice.ec.gc.ca)

→ 1995-2015 - 2016

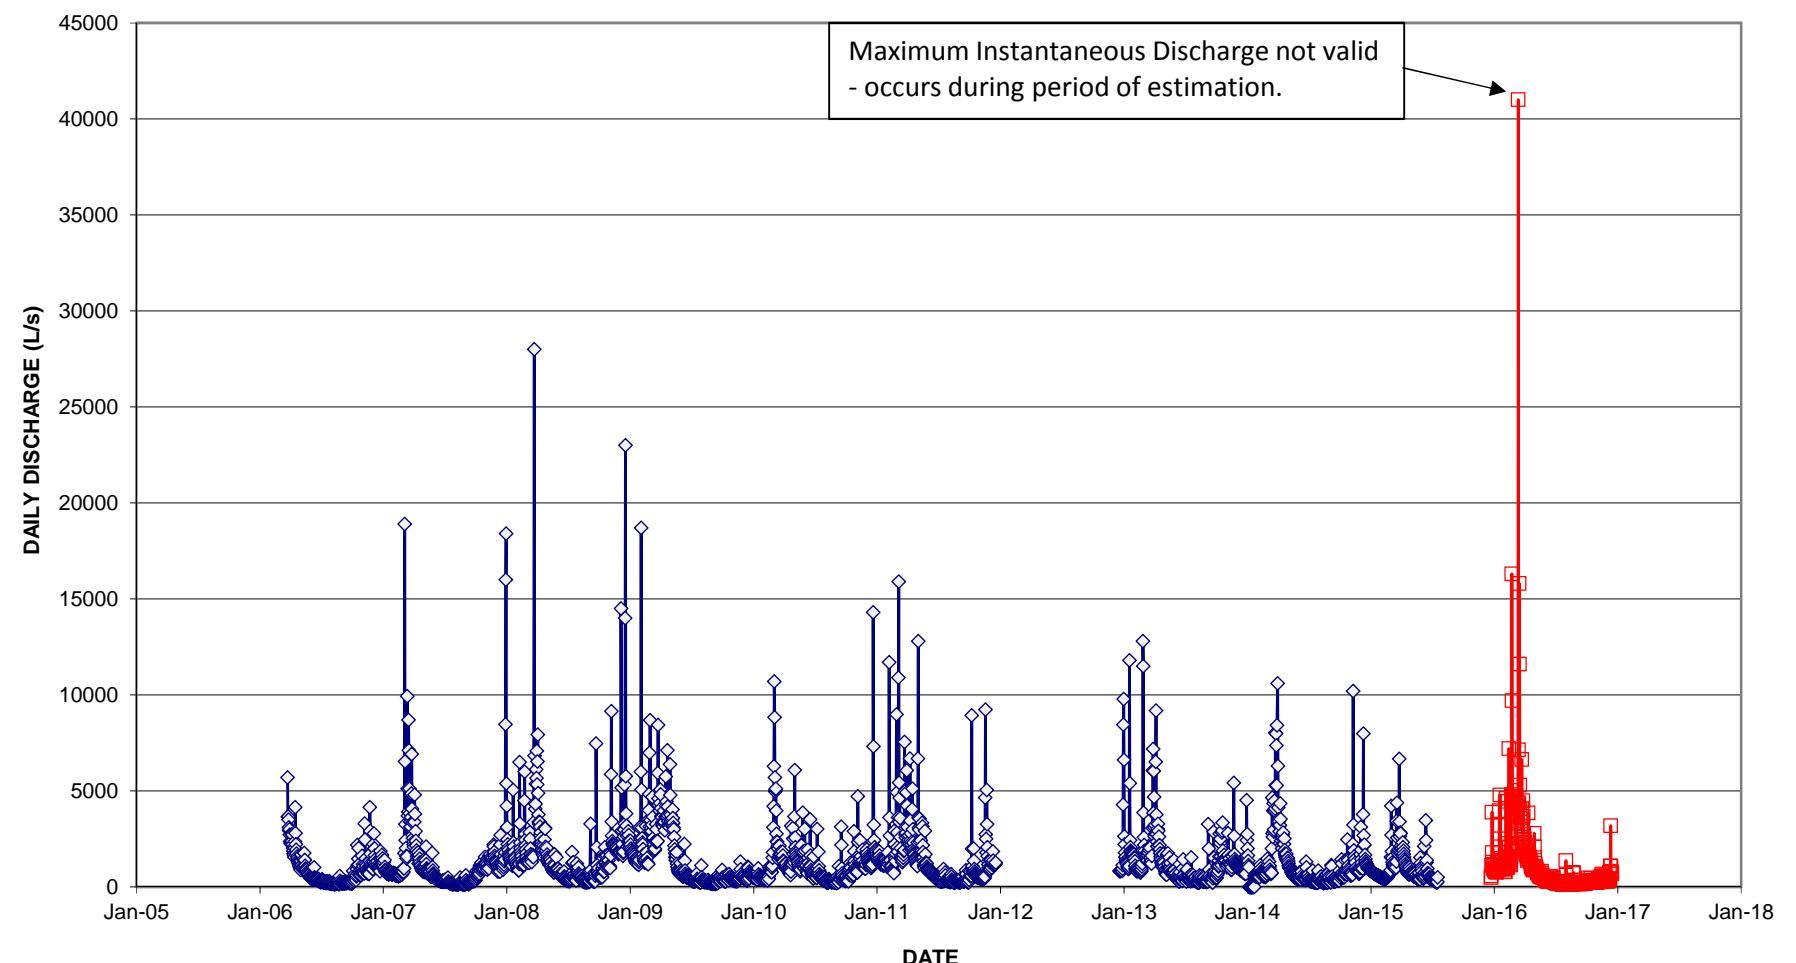
FIGURE A-7

SURFACE WATER HYDROGRAPH Pretty River at Collingwood Environment Canada Station 02ED031

DATE NOTE: Data for this graph obtained from Government of Canada Hydrometric Data Station 02ED031 (https://wateroffice.ec.gc.ca)

→ 2006-2015 - 2016
