DUNTROON EXPANSION QUARRY

ADAPTIVE MANAGEMENT PLAN ANNUAL SUMMARY REPORT

WALKER AGGREGATES INC.

PROJECT NO.: 111-53312-00
DATE: APRIL 27, 2018

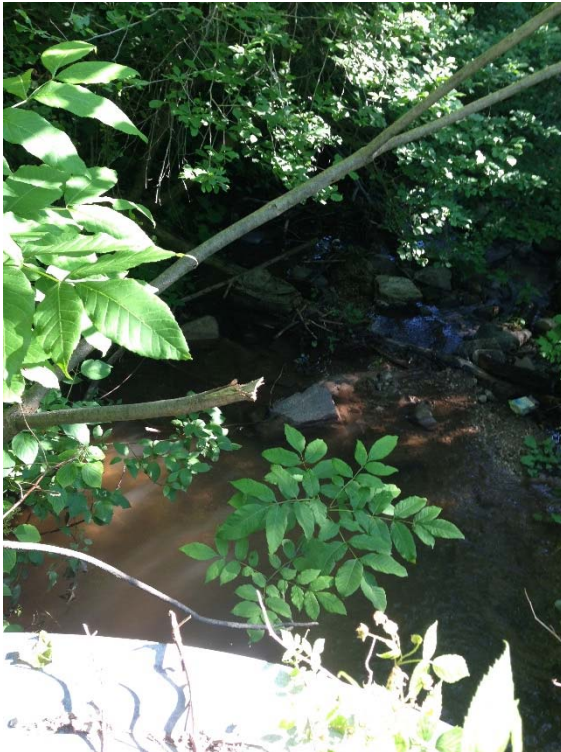
Photo 1 - Batteaux Creek sub-watershed control station

- Batteaux Creek Sub-watershed Station (“BC Control”) – surface water control station located at the north side of the road culvert on 21/22 Sideroad, Clearview Township, approximately 1350 m east of Concession 10.
- Pretty River Sub-watershed Station (“PR Control”) – surface water control station located at the north side of the road culvert on 30/31 Sideroad, Town of the Blue Mountains, approximately 390 m west of the boundary line between Clearview Township and Town of Blue Mountains.
